December 1981

**THE STREAMBANK EROSION CONTROL
EVALUATION AND DEMONSTRATION ACT OF 1974
SECTION 32, PUBLIC LAW 93-251**

Appendix B - Hydraulic Research

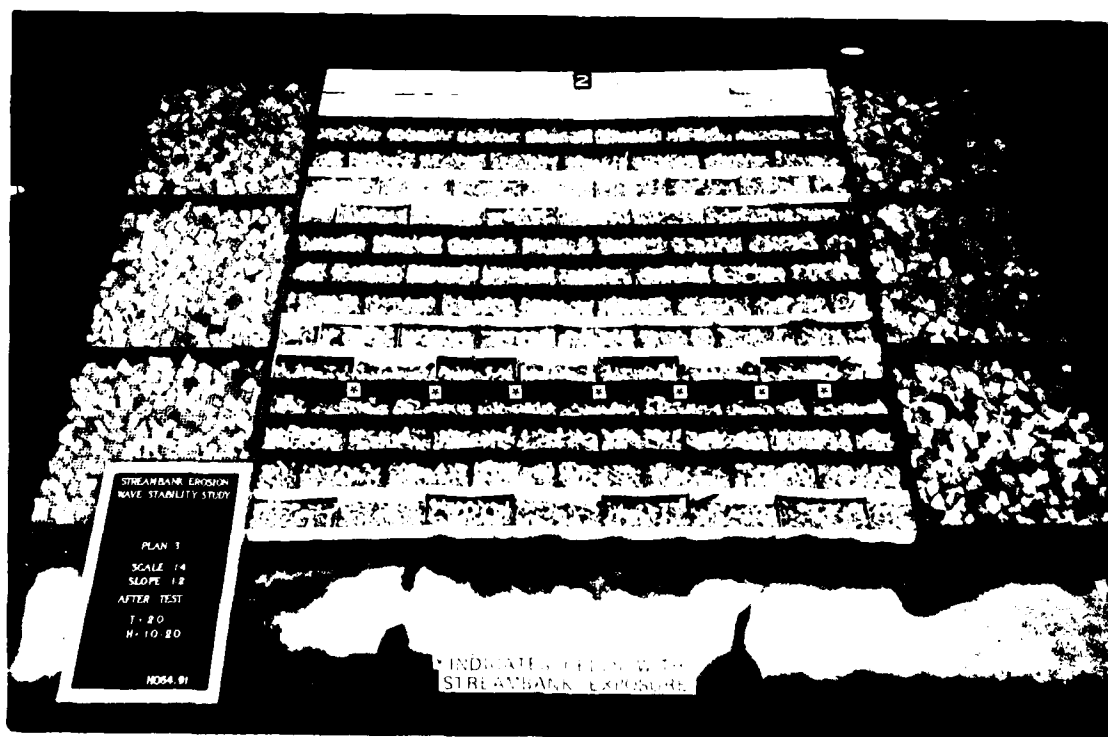
Figure 26. Plan 3, after exposure to 2.0-sec, 1.0- to 2.0-ft nonbreaking waves; wave direction 2

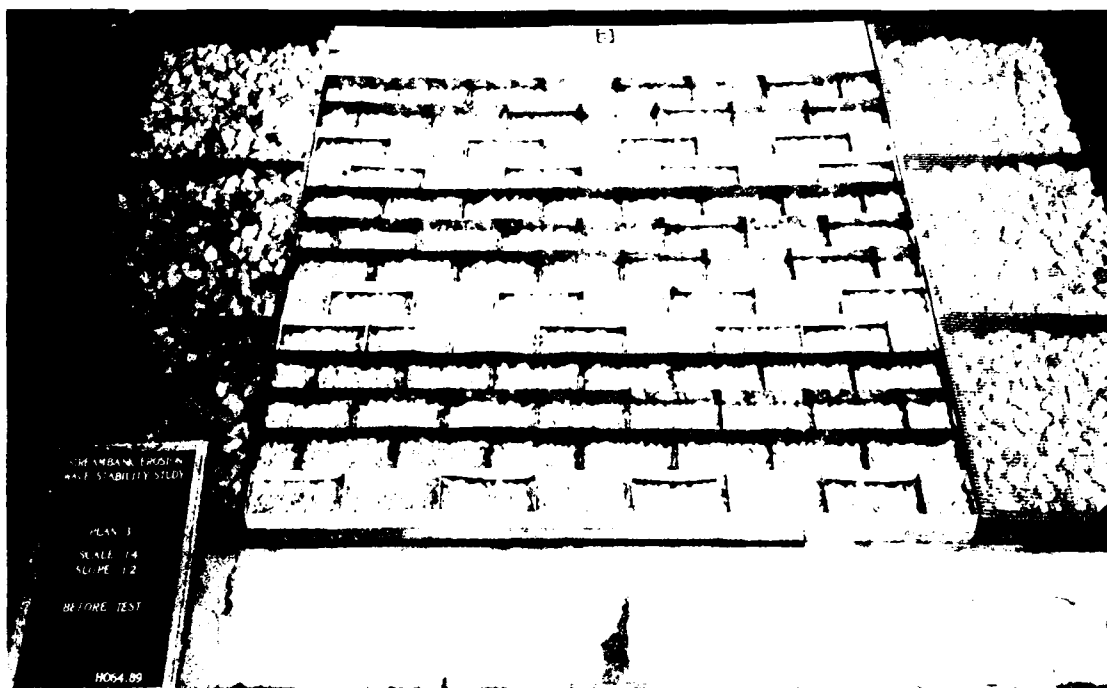
Figure 28. Plan 3, before wave attack from wave direction 3

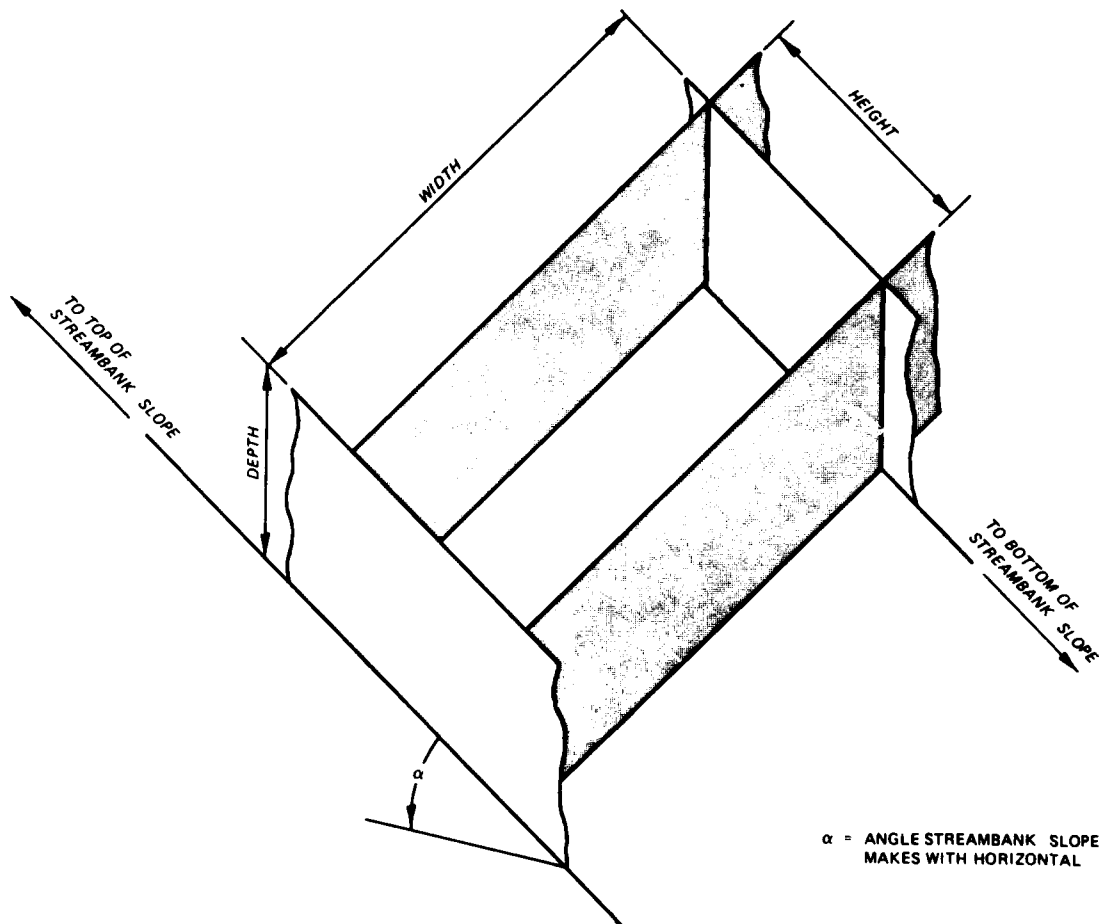
Figure 42. Nomenclature for cell sizing
